## Wallboard Woes

## Odors and corrosion raise concern over drywall imported from China

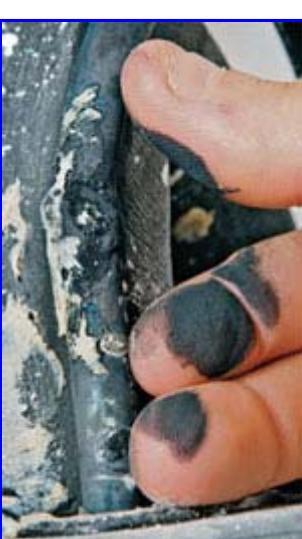
View Enlarged Image Dark Mark Black corrosion forms on a copper air conditioner coil in a house in Florida built with Chinese drywall that emits sulfurous gases. hydrogen sulfide may originate with sulfur or metal sulfide particles in the drywall or could come from hydrolysis of carbonyl sulfide gas emitted by the drywall.

WHAT'S MORE worrisome has been the corrosion of copper pipes, wiring, and air conditioner coils. These copper surfaces turn black and powdery in homes with the suspect drywall. This type of corrosion is indicative of reaction with hydrogen sulfide, several chemists tell C&EN. The
